A27 Arundel Bypass Bat Structures Baseline Survey

Appendix 8-7: Bat Structures Baseline Survey Report

06 August 2019

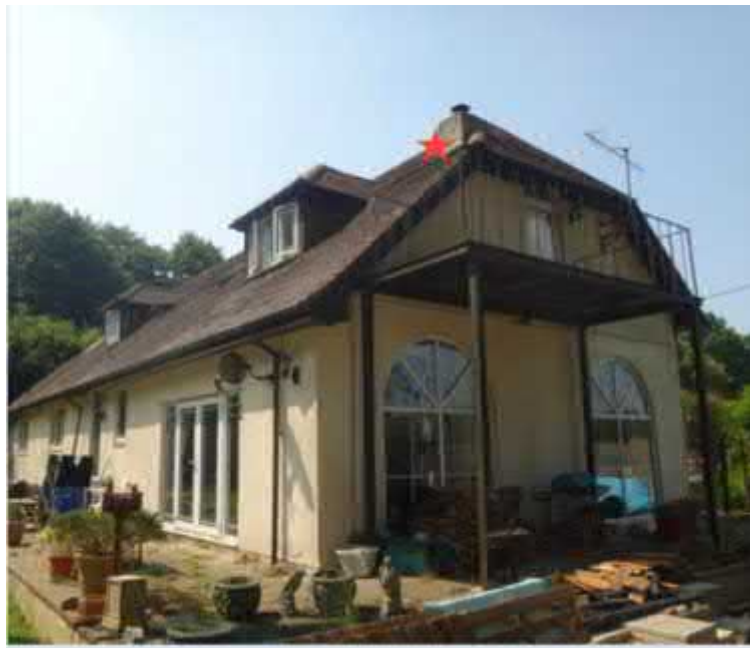
Egress point
close to
chimney
stack on
north east
elevation

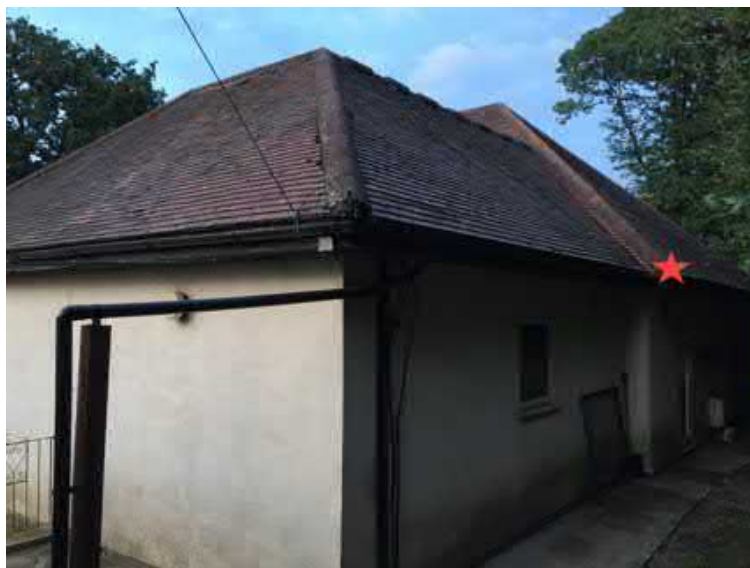
Egress point
on south
elevation

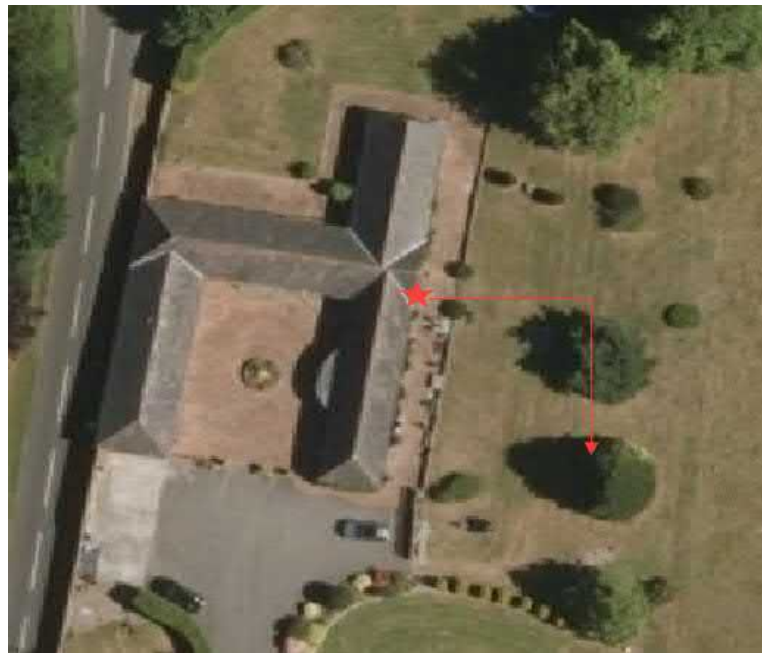
Structure 5:

Aerial image of Structure 5, showing the flight line from the egress point

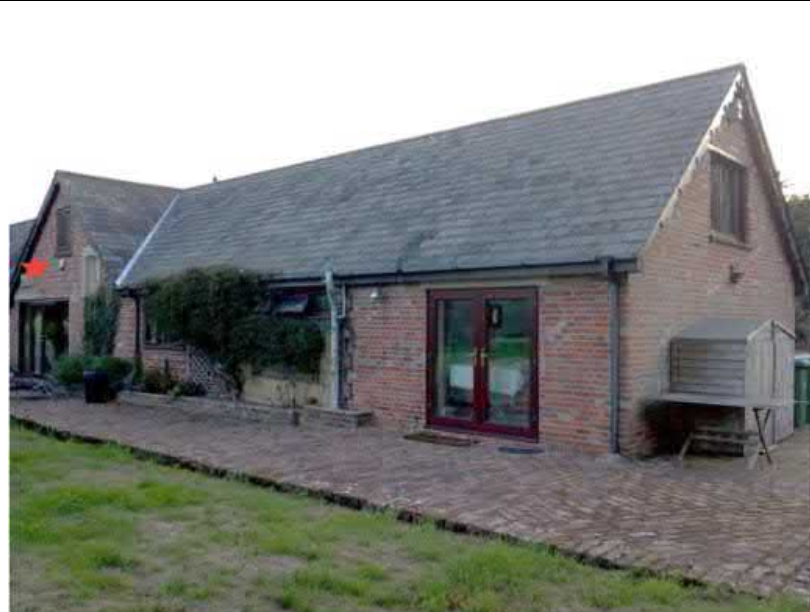
Egress point beneath apex roof on eastern elevation

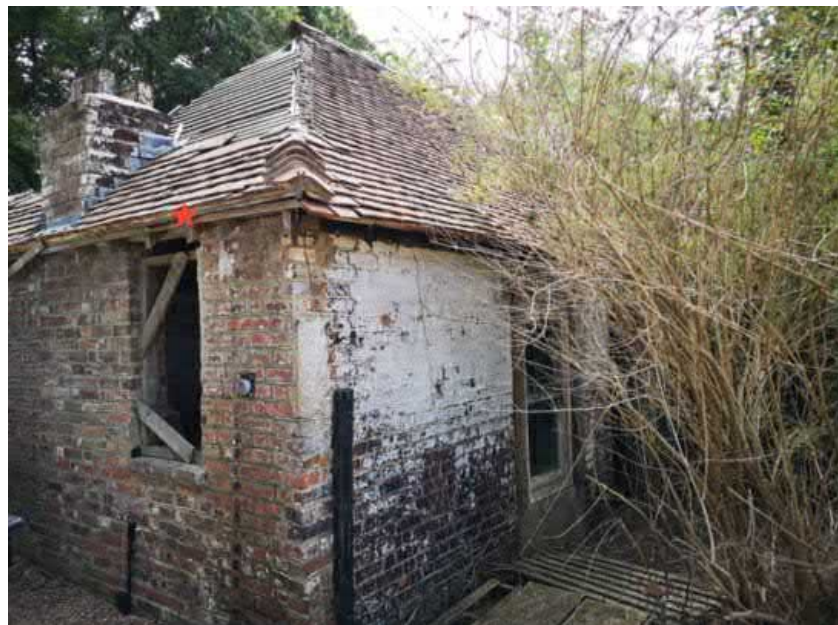
Egress point at edge of overhanging roof on northern elevation

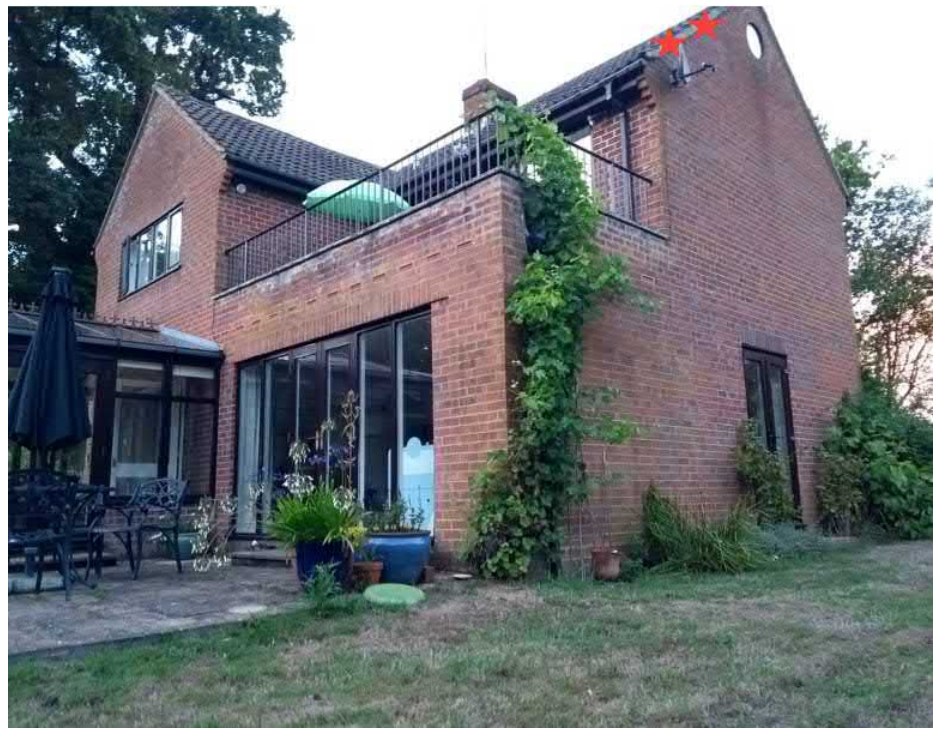
Egress and re-entry points on the southern gable end. Soprano pipistrelle observed entering and emerging

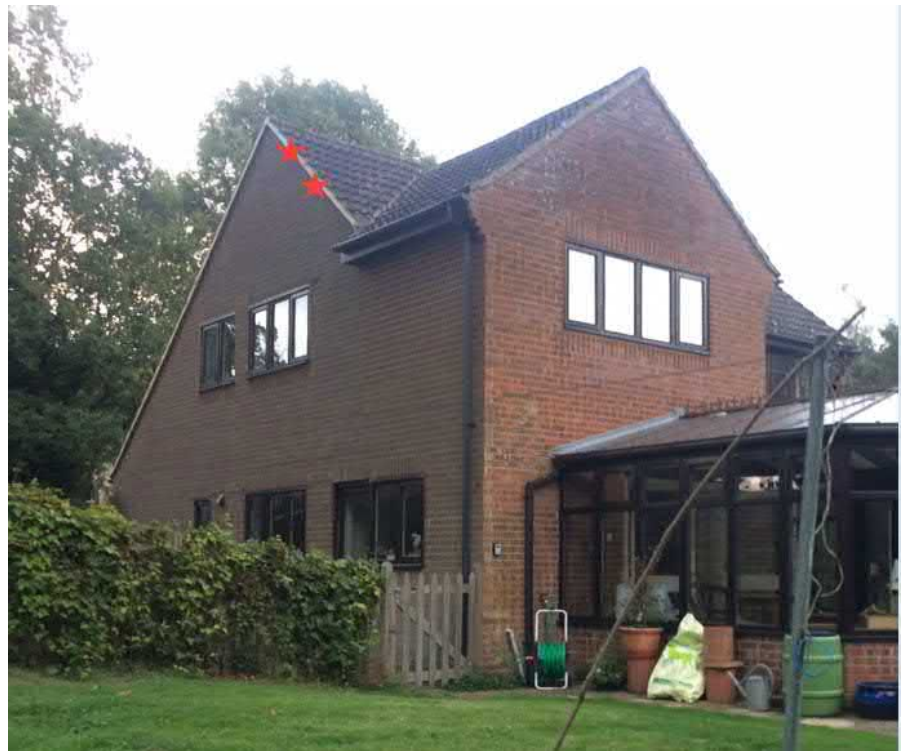
Re-entry points of soprano pipistrelle on northern elevation near apex of roof

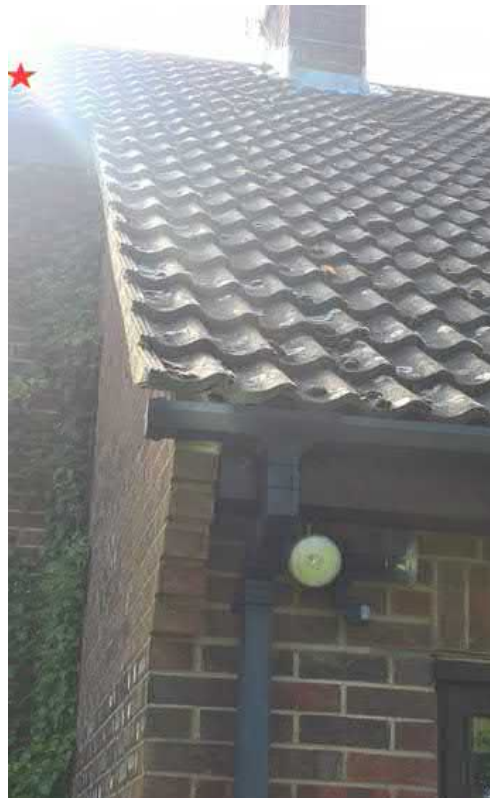
Re-entry point
on eastern
elevation
where
multiple
soprano
pipistrelle
were
observed
entering
under a tile

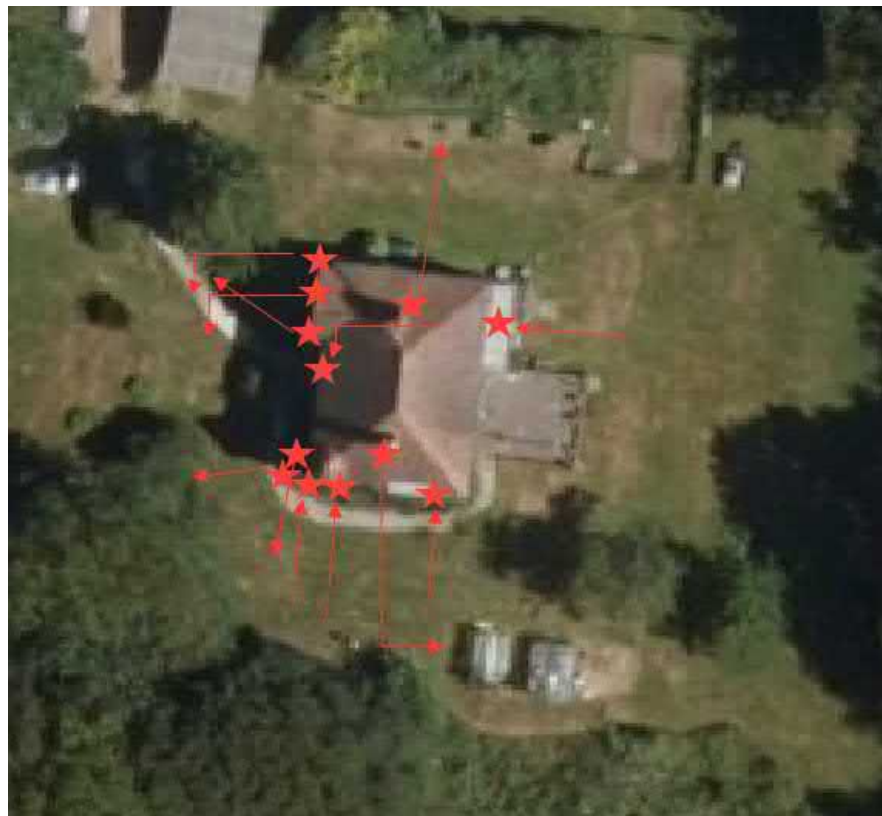
Structure 42:

Aerial image
of Structure
42, showing
the flight line
from the
egress and
entry points

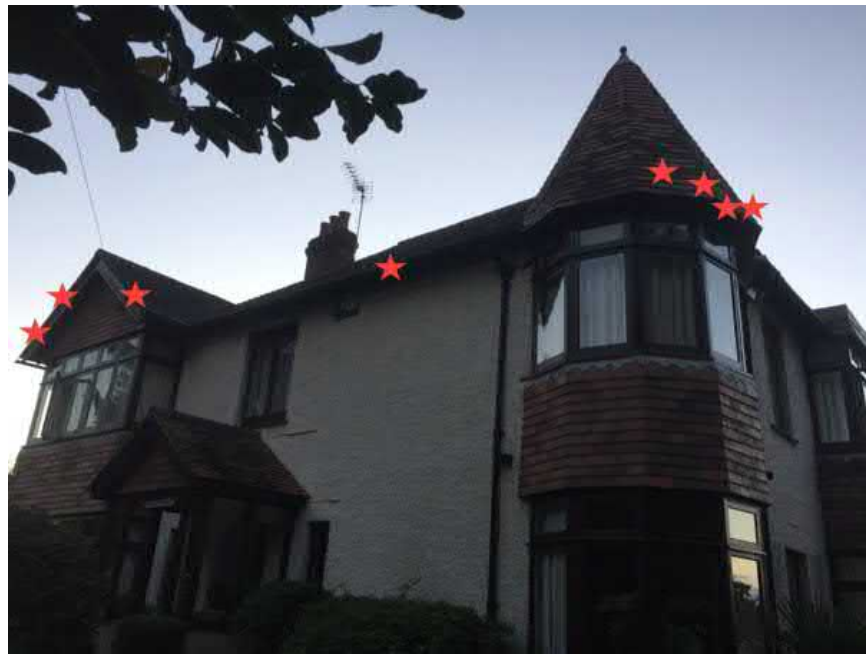
Re-entry points of soprano and common pipistrelle on southern and western elevations

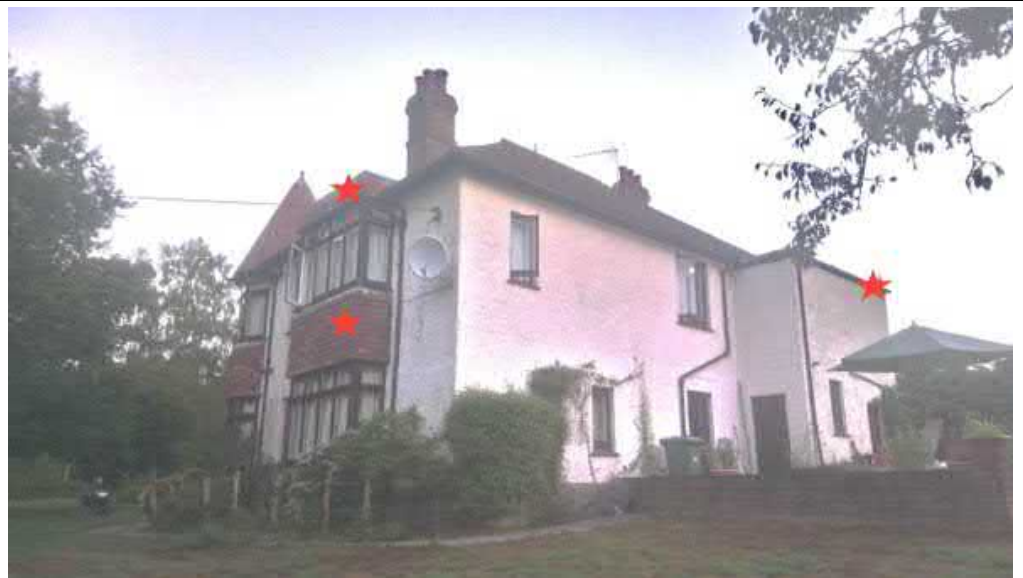
re-entry points of common pipistrelle on southern and eastern elevations

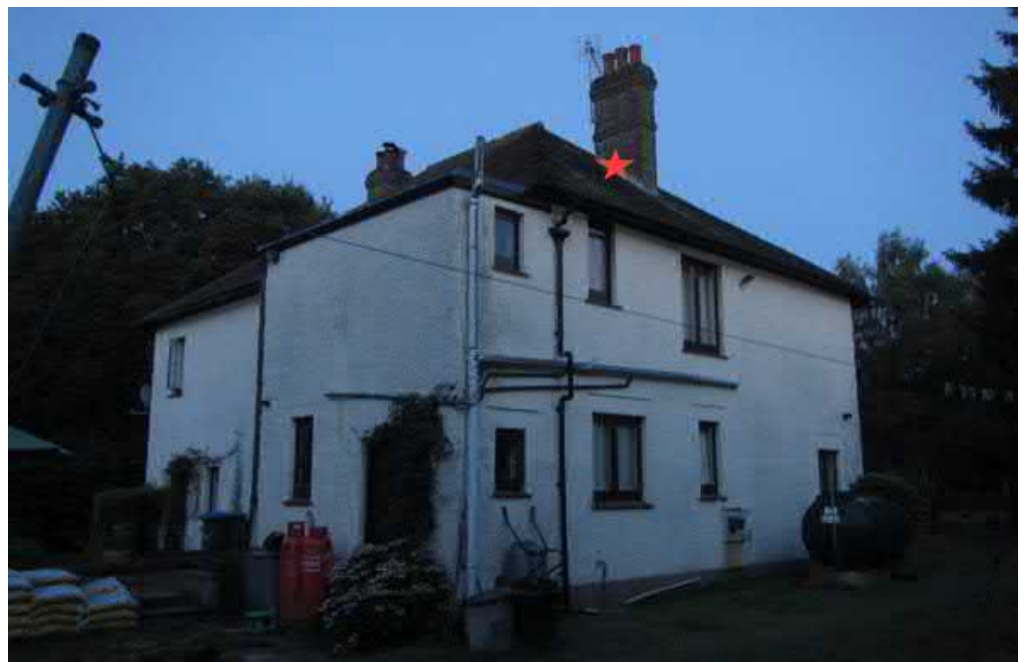
Egress point
at base of
chimney on
northern
elevation

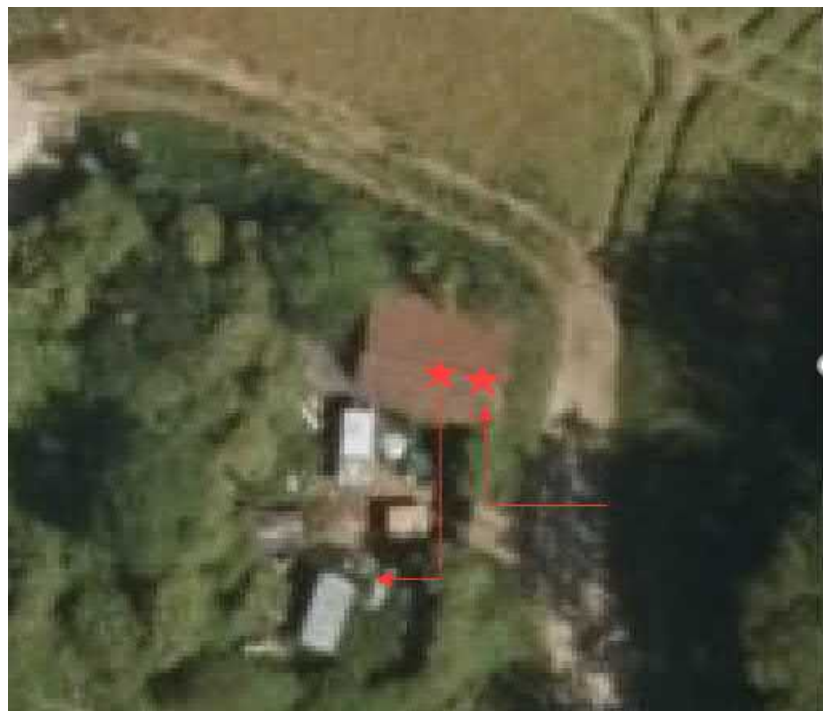
Structure 47:

Aerial image
of Structure
47, showing
the flight line
from the
egress and
entry points

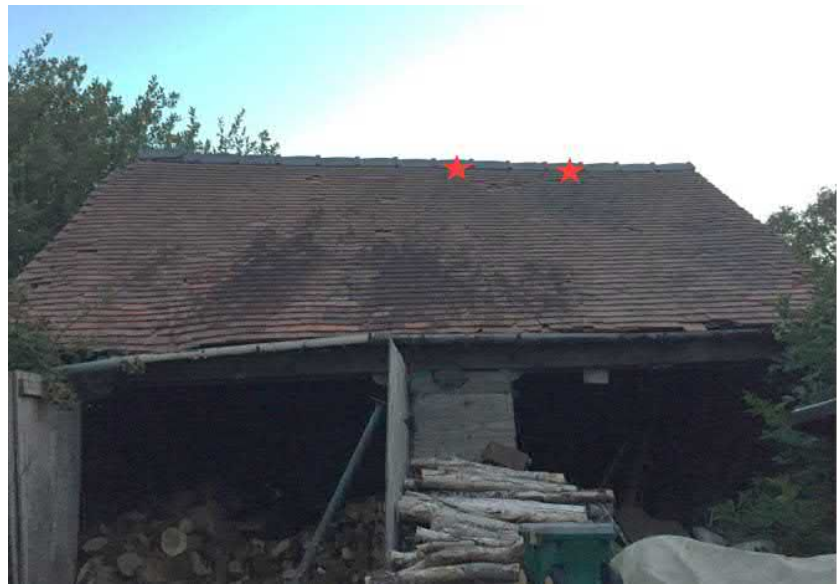
47	2018	10765	1. Dawn re-entry 2. Dusk emergence	<p>Survey 1- Re-entry, 2018:</p> <ul style="list-style-type: none"> At least one common pipistrelle observed re-entering beneath ridge tile on western elevation Multiple common pipistrelle passes, social calls and circling during the survey. No other species recorded. <p>Survey 2 - Emergence, 2018:</p>

Re-entry and emergence points of common pipistrelle on the south elevation in location of missing tile at approximately the fourth apex tile and under seventh apex tile from right in image

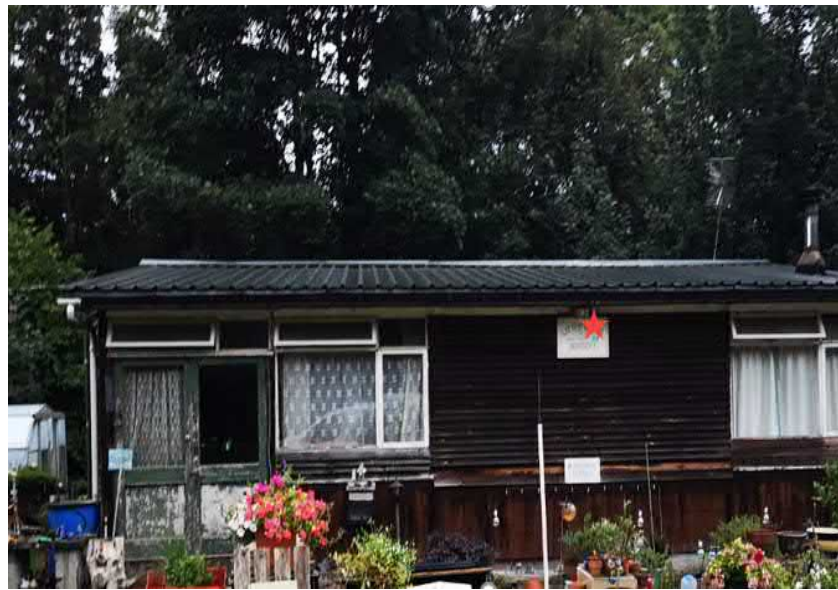
Entry point of
a soprano
pipistrelle on
the south-
western
elevation

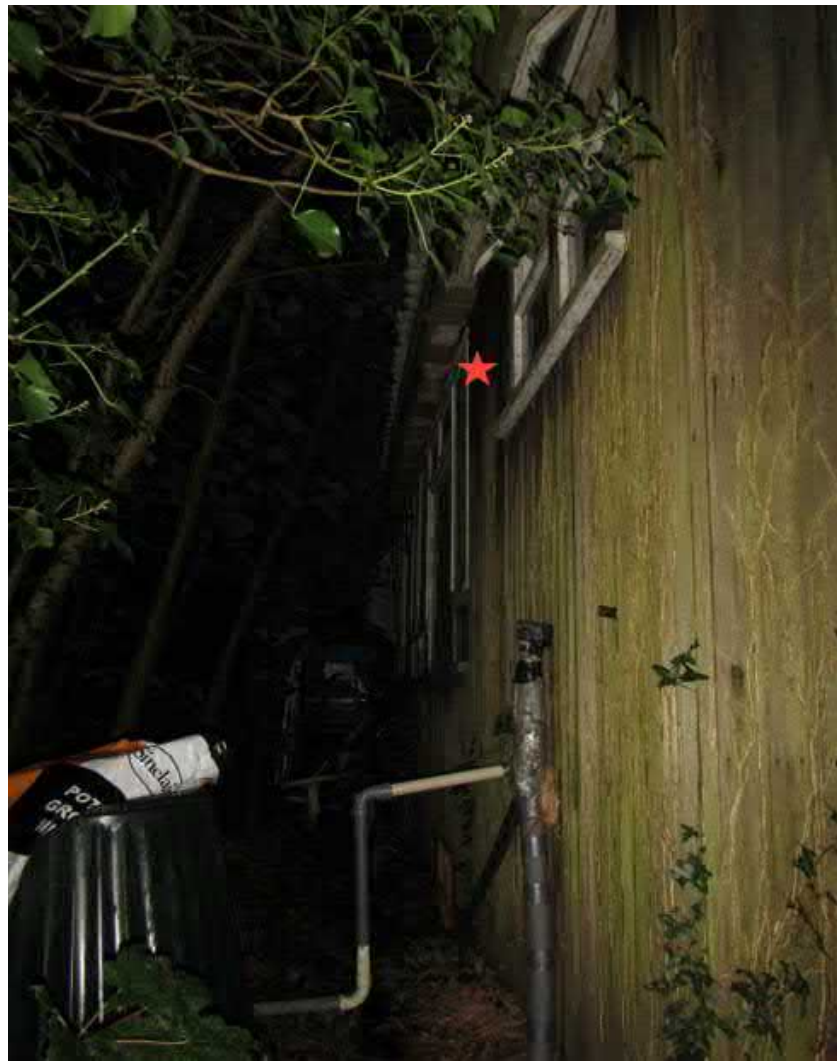
Entry point of
soprano
pipistrelle
behind a sign
on the north-
eastern
elevation

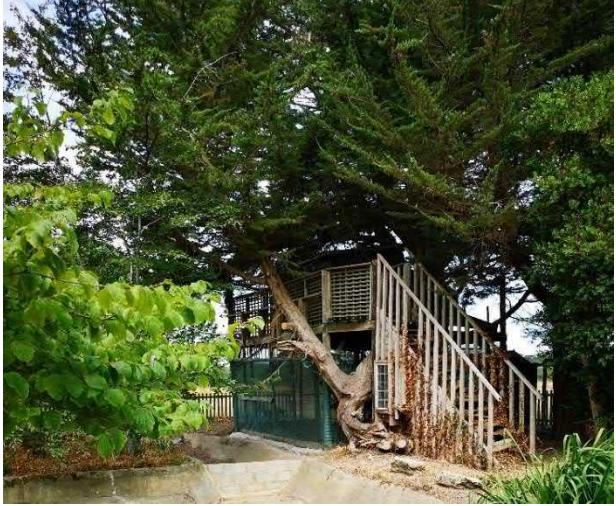
31	10320 – timber framed structure	Elevated timber tree house with timber steps to access. Unsafe to access due to fragile timbers.	Unsafe for internal inspection	Few small gaps where timber has rotted and broken away in places	Low
32	10320 – Dwelling house	Single storey brick gate house with a hipped roof clad with clay roof tiles.	Not internally inspected due to access restrictions	Cavities above the western window with bat roost potential. Internally the building is open to the apex and a large hole on the southern elevation	Low
33	13146 – Dwelling house	Single storey with roof windows. Flint and brick construction with a half-hipped gable end roof. Timber weather boarding on gable ends	Not internally inspected due to access restrictions	Crevices visible around the roof vent although appeared to be lined	Low
34	10550 – Static caravan	Single storey static caravan home with flat roof.	Not internally inspected due to access restrictions	Crevice visible beneath roof on northern elevation	Low

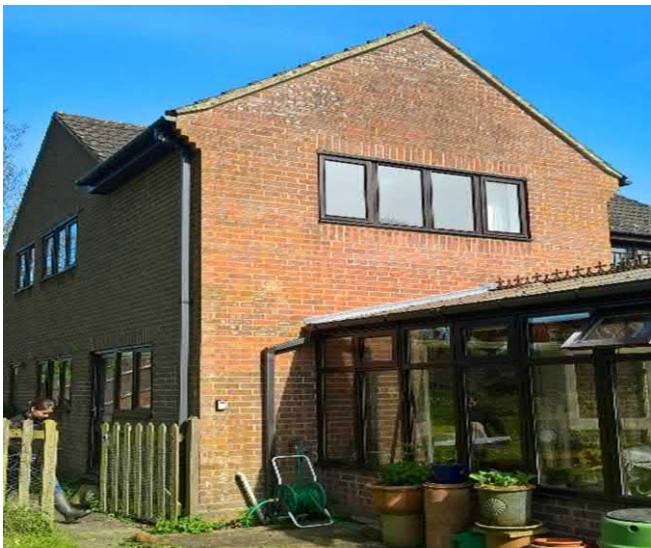
40	12765 – dwelling house

40	12765 – Dwelling house	Brick two-storey residential home with clay tiled, hip roof. Soffit boxes where roof meets brick walls and lead flashing around chimney base	Large roof void; extends throughout whole roof space. Timber; cluttered roof void due to truss construction. Lined with bitumen felt throughout. High light ingress due to window in gable. Low temperature. Approximately 300 bat droppings recorded.	Two crevices observed above – one above gutter and below tiling of the roof and one hole at the end of the soffit	Moderate
42	12688 – Dwelling house	Pebbledash walled, two-storey house. Hipped, tiled roof with an additional flat, metal-roofed extension. Lead flashing around base of chimney. Tiling around windows on south elevation. Tiled, tower-type structure on south west corner	Not internally inspected due to access restrictions	Multiple lifted tiles between first and second storey around windows suitable for individual bats. Several potential crevices under eaves. Most features on southern and western elevations. Surrounding habitat quality is good	Moderate

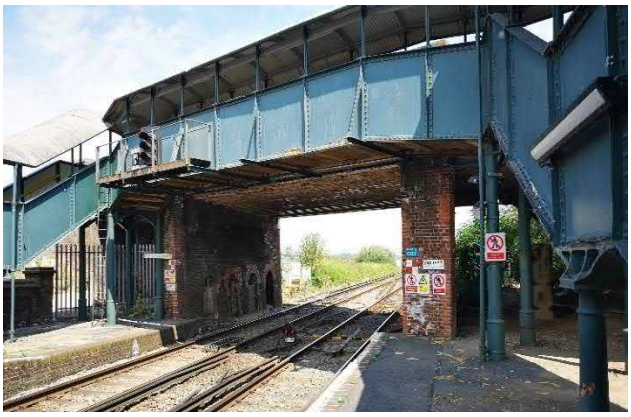
48	16210 - bridge

48	16210 – Road bridge over railway	Railway overbridge of brick construction with steel girder and concrete deck with metal braces beneath and metal parapets.	Not internally inspected due to access restrictions	Approximately five potential roost features of low suitability including areas where mortar is missing under the arches and concrete is missing from the under deck	Low
63	12735 – timber shed	Timber framed single storey building clad with timber weatherboarding. Timber soffit box around roof. Bitumen roofing felt with corrugated metal sheeting	Not internally inspected due to access restrictions	Gaps between corrugated sheeting and bitumen. Gap between 'little woods nursery' sign and timber boarding on south-western elevation	Low
64	12735 – timber shed	Timber framed and timber clad single storey storage room. Corrugated asbestos, overhanging pitched roof	Not internally inspected due to access restrictions	Large gaps between top of wall and roof under eaves on all elevations under asbestos sheeting. Some chicken wire present filling/plugging some of the gaps.	Low
