A27 Arundel Bypass Watercourse Vegetation Baseline Survey Report

Appendix 8-16: Watercourse Vegetation Baseline Survey Report

16 August 2019

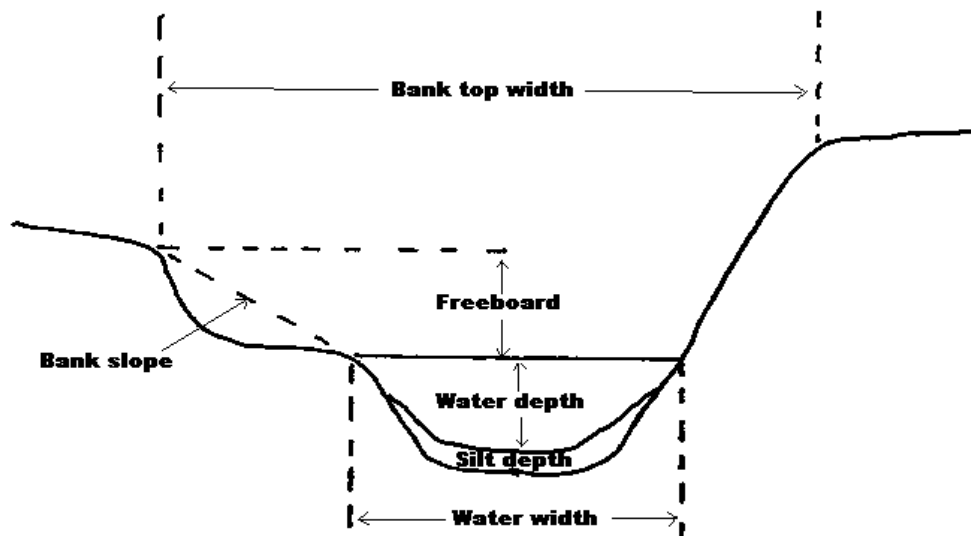
Ditch features

The recording form gives bandings for recording bank top and water widths, freeboard and bank slopes. These features should be recorded by ticking between the appropriate figures. *** should water width and depth be based on actual or estimated normal (when obviously lowered or drying out)????

Water and silt depth should be recorded to the nearest 10 cm.

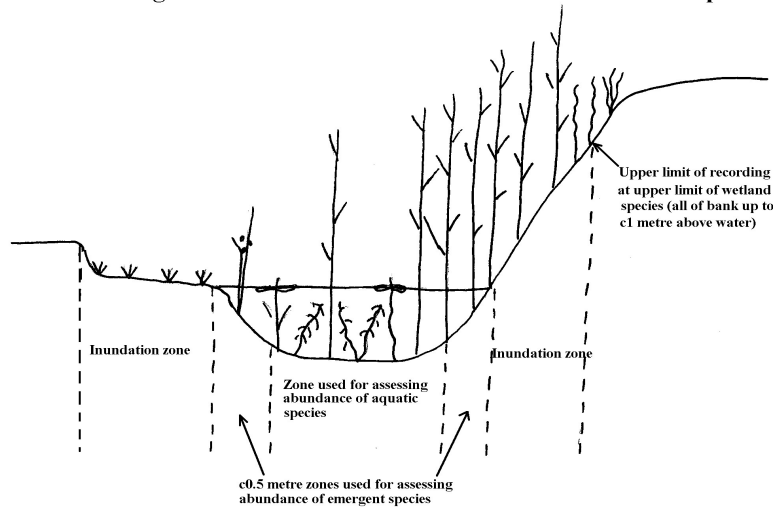
FIGURE 1 - Diagram of the zones used to assess the abundance of species

The three zones are defined as follows. The aquatic zone covers all submerged and floating vegetation (excluding the underwater parts of emergent species). Only a few species in this zone overlap with other zones but these should be recorded for whichever zones are appropriate. Thus unbranched bur-reed *Sparganium emersum* is often scored mainly for the aquatic zone but also as present in the emergent zone. Young plants of water plantain *Alisma plantago-aquatica* should be scored as aquatic when they are not part of emergent plants and terrestrial plants of water starwort *Callitriche* spp should be scored in the inundation zone. However, floating pennywort *Hydrocotyle ranunculoides* should be recorded for the aquatic or inundation zones even though it is often becomes slightly emergent where it is growing densely.

The emergent and inundation zones have a high degree of overlap in their species content and there is rarely any significant discontinuity between the two. The boundary should therefore be taken as the edge of the water at the time of survey.

The definition of the inundation zone should be "close to the water's edge on the lower bank, ie on that portion of the bank that, in the judgement of the field surveyor, appeared to be regularly flooded" (e.g. Leach et al. 1991). The upper limit of this definition is often difficult to interpret as there is rarely any marked vegetation boundary and indeed many ditches overtop their banks periodically in the winter. It may be easier to define this as the zone dominated by wetland species, or, where *Agrostis stolonifera* is the dominant species, where the associated species are mainly wetland species. Often this includes much or all of the banks except where they exceeded about one metre freeboard.

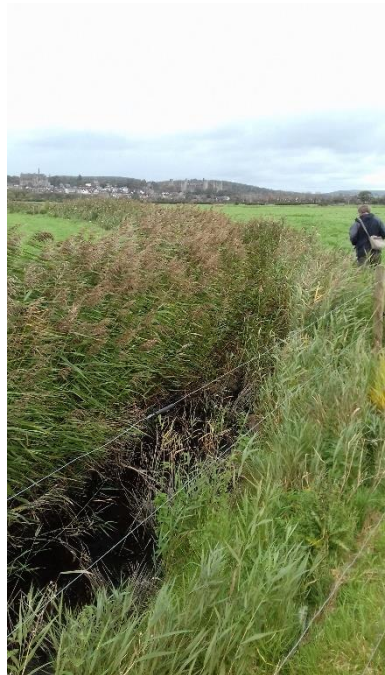
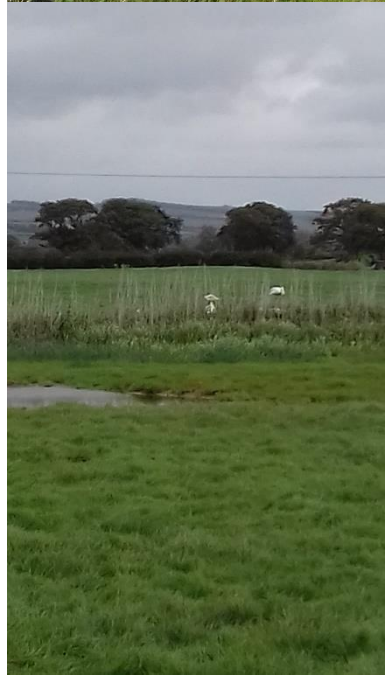
AQ010

12260_PH2_NS_AQ010_P1_111017
12260_PH2_NS_AQ010_P2_111017

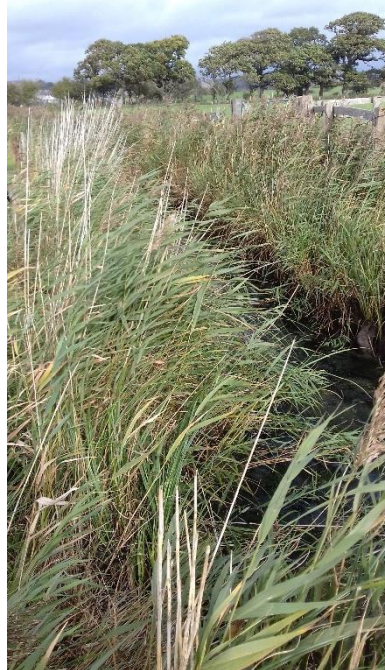
AQ013A

12260_PH2_NS_AQ013A_P1_11101
7

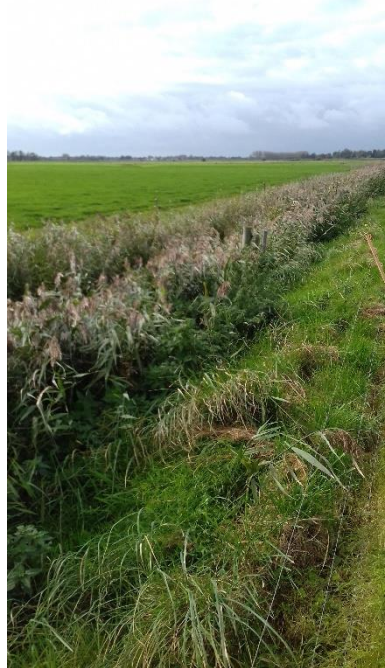
AQ013B

12260_PH2_NS_AQ013B_P3_11101
7

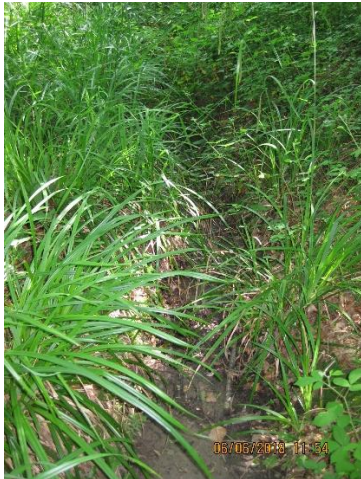
<p>11765_PH2_NS_AQ078B_P1_060618</p>
<p>AQ078C</p>

AQ070 Streamlet	Open woodland with abundant bracken resulting in it being effectively shaded. It is a shallow streamlet with no aquatic vegetation.
AQ078A	A shallow ditch with a silted bed running through arable land, vegetation is dominated by hemlock water-dropwort.
AQ078B	The ditch enters ash and oak woodland and becomes dry. Pendulous sedge is found within channel with bramble on banksides

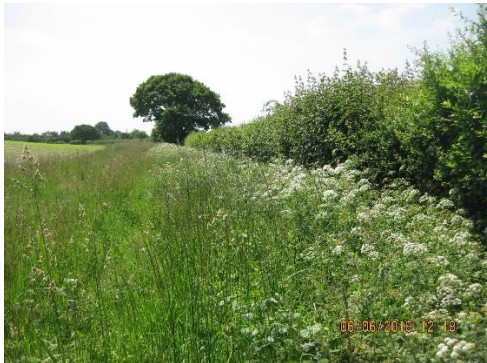
<p>11765_PH2_NS_AQ078C_P1_060618</p>

Water-course	Description
AQ078C	A shallow ditch with a silted bed running through arable land, vegetation is dominated by hemlock water-dropwort. A hedge borders the west of the bank of the ditch with rough MG1 <i>Arrhenatherum elatius</i> grassland to the east.
AQ091 Ditch	A dry ditch mostly under willow etc. scrub and difficult to follow for most of its route. Under the shade there is a mixture of bare ground, nettle dominated areas and woodland ground flora communities (e.g. ivy). There is a short stretch with broken shade at the western end which has abundant common reed.
AQ093 Ditch	A dry ditch with gently banks running through improved pasture. The bottom is dominated by creeping bent and Yorkshire fog with some sweet-grass. The banks have creeping bent, Yorkshire fog and perennial rye grass with some common nettle and spear thistle.
AQ100	Small stream in area of ancient woodland (Hundredhouse Copse). Heavily shaded and supporting little aquatic vegetation other than occasional areas of water mint (<i>Mentha aquatica</i>), lesser water parsnip (<i>Berula erecta</i>) and sparse aquatic mosses. The stream is surrounded in places by alder and ash wet woodland which has been surveyed in the NVC woodland baseline survey report. Scoped out from further aquatic plan survey as woodland vegetation present and few aquatic plants present.
