A27 Arundel Bypass Bat Structures Baseline Survey

Appendix 8-7: Bat Structures Baseline Survey Report

06 August 2019

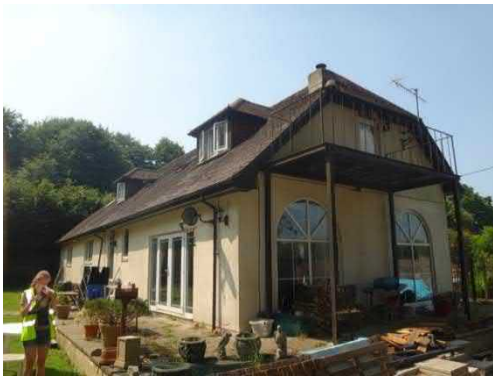
Structure number	Structure reference and type	Plate
1	10550 - Dwelling house

Structure number	Building Ref.	Surveys completed	Grid Reference	Description	Features present	BCT suitability ³⁸ and confirmed roost (if applicable)
1	10550 - Dwelling house	<ul style="list-style-type: none"> External PRA Two emergence surveys 	SU 98273 07254	Detached residential home. Two storey brick build. Building is located within high quality habitat	Several broken tiles on all elevations although majority on western elevation. Several gaps observed close to dormer window on west elevation.	Moderate - Confirmed roost
2	10550 – Dog kennel	<ul style="list-style-type: none"> External PRA 	SU 98275 07238	Small shelter appearing to be a dog kennel. Open and exposed internally.	No features suitable for roosting bats observed	Negligible
3	10900 - Dwelling house	<ul style="list-style-type: none"> External PRA 	SU 99758 07347	Detached residential home. Two storey brick build with assumed loft conversion. Tiled roof with chimney stack	Multiple access points for roosting bats ³⁹	Moderate

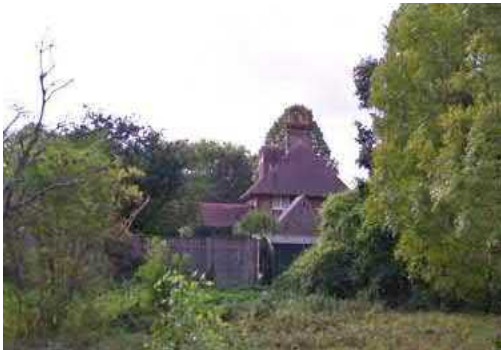
(from google maps)
4	10900 - Shed/workshop

4	10900 - Shed/workshop	<ul style="list-style-type: none"> External PRA 	SU 99759 07324	<i>No description or photos due to data error.²</i>	No features suitable for roosting bats observed	Negligible

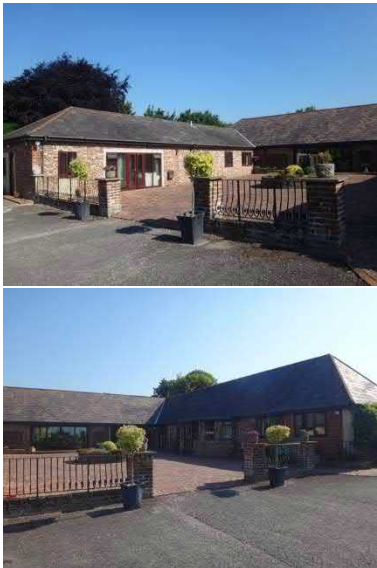
5	10375 - Dwelling house	<ul style="list-style-type: none"> External PRA Internal PRA One emergence and one re-entry survey 	SU 97096 06771	<p>Single storey brick built bungalow with 2m high walls and pitched roof to a height of 4m at ridge. Roof tiled with slate tiles and ridge and hip tiles were clay / concrete fibre. Brickwork, pointing and roof tiles all in good condition and well maintained. Closed wooden soffit box that was tight fitting. Ridge tiles and lead flashing tight fitting. Wooden bargeboards on east facing gable with closed wooden soffits. Small flat-roofed new extension with roofing felt present on eastern 'leg' of dwelling in good condition. No evidence of roosting bats observed.</p> <p>Building is located within high quality habitat.</p>	<ul style="list-style-type: none"> Some raised slate tiles on eastern elevation Slipped wooden plank under soffit on north-eastern corner that is a potential access point (no signs). Wooden bargeboard with closed soffit on northern elevation with some gaps between the brickwork and soffit. Raised roof tiles on other elevations, including adjacent to bargeboards. Gaps between soffit and brickwork on western elevation go up into internal soffit space. No droppings present. 	Moderate – Confirmed roost

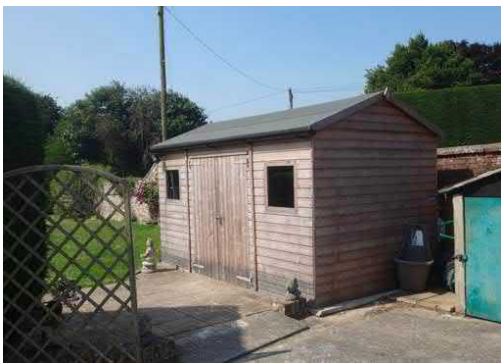
6	10375 - Shed in garden	<ul style="list-style-type: none"> External PRA 	SU 97103 06737	Timber-framed garden shed, timber weatherboarding with bitumastic felt covered	No features suitable for roosting bats observed	Negligible

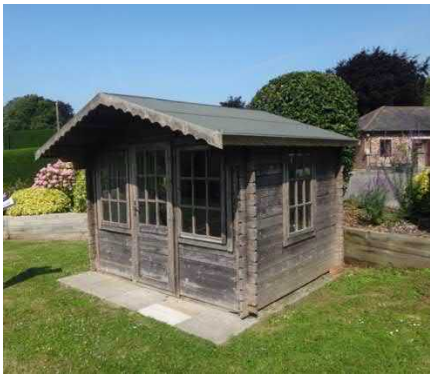
pitched roof. Good condition		
7	10375 - Shed in garden next to boundary wall	<ul style="list-style-type: none"> External PRA 	SU 97071 06740	Timber-framed garden shed, timber weatherboarding with bitumastic felt covered pitched roof. Good condition	No features suitable for roosting bats observed	Negligible
8	10375 - Shed on western side of small copse	<ul style="list-style-type: none"> External PRA One emergence survey 	SU 97224 06752	Flat-roofed timber shed with timber weatherboarding to 2m in height	<ul style="list-style-type: none"> Gap between the timber face and roof on west side of the shed No other features observed 	Low
9	11250 - Garden shed 1	<ul style="list-style-type: none"> External PRA 	TQ 00586 05861	Timber-framed garden shed, timber weatherboarding with bitumastic felt covered pitched roof. Good condition	No features suitable for roosting bats observed	Negligible
10	11250 - Garden shed 2	<ul style="list-style-type: none"> External PRA 	TQ 00622 05831	Timber-framed garden shed, timber weatherboarding with bitumastic felt covered pitched roof. Good condition	No features suitable for roosting bats observed	Negligible

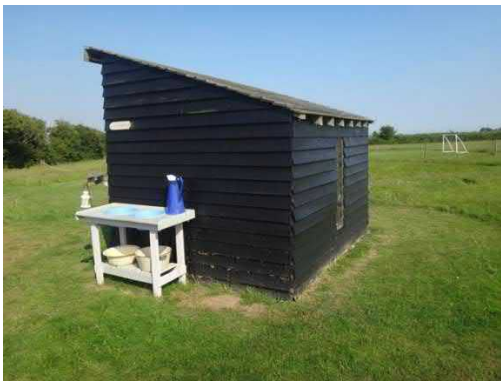
14	11235 - Timber-framed outbuilding	<ul style="list-style-type: none"> External PRA 	TQ 00999 05715	Timber-framed garden shed, timber weatherboarding and roof. Good condition	No features suitable for roosting bats observed	Negligible
15	11765 – Derelict farm building 1	<ul style="list-style-type: none"> External PRA 	TQ 01678 06051	Derelict brick building. No roof	No features suitable for roosting bats observed	Negligible

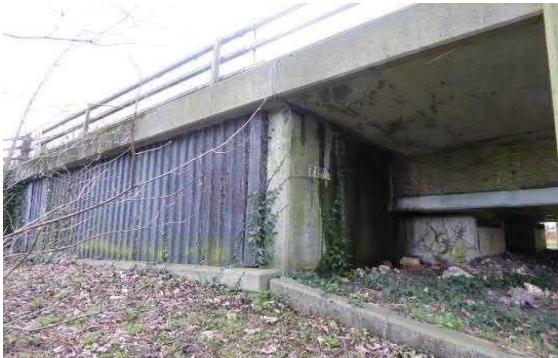
16	11765 – Open farm building 2	No photograph available
17	12275 – Derelict farm building	No photograph available
18	11221 One of the two bridge abutments that require a further survey. Dark void behind the corrugated sheet.

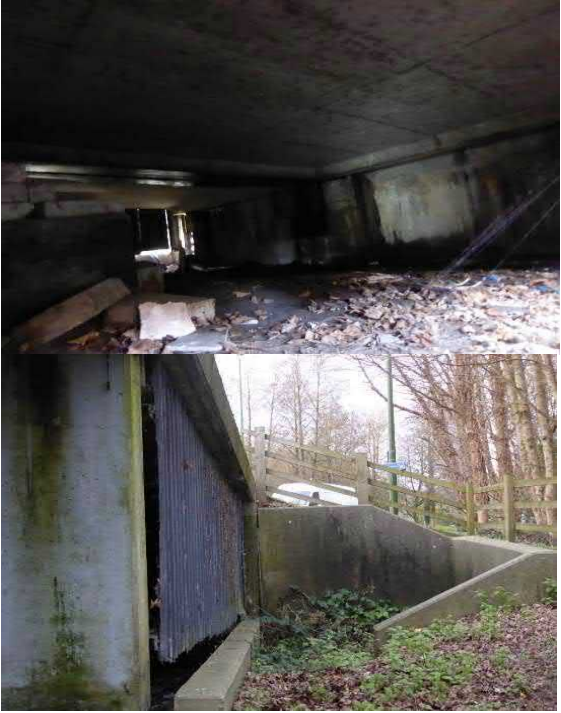
<p>Void inside abutment which may provide roosting opportunity</p> <p>Entrance to abutment void</p>

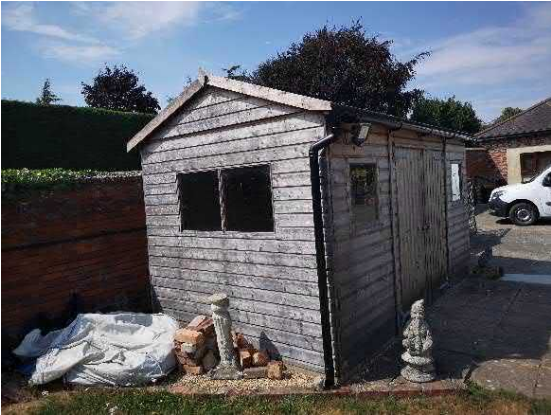
20	10375 – timber shed

19	12730 - Railway Bridge	Not surveyed- no access permitted	TQ 02286 06069	Not surveyed- no access permitted	Not surveyed- no access permitted	Unknown
20	10375 - Timber shed	<ul style="list-style-type: none"> External PRA 	SU 97076 06736	Timber shed with bitumen roof and double doors. Appears intact and maintained. High light ingress through windows and attached lighting.	No features suitable for roosting bats observed	Negligible
21	10375 - Timber shed	<ul style="list-style-type: none"> External PRA 	SU 97081 06728	Small timber shed with large windows allowing high levels of light ingress. Bitumen felt roof.	No features suitable for roosting bats observed	Negligible
22	10350 - Dwelling house	<ul style="list-style-type: none"> External PRA Internal PRA One emergence survey 	SU 97034 06872	<p>Semi-detached house with clay tiles and hip and valley roof. Structure generally in well-maintained condition</p> <p>Large roof void extending throughout whole roof space. Simple timber frame roof with purlins, collar beams, struts, rafters and ridge board. Fully lined with bitumen felt.</p>	Some loose tiles on gable and main roof. Small void visible beneath a wood panel beneath a drainage gutter.	Moderate

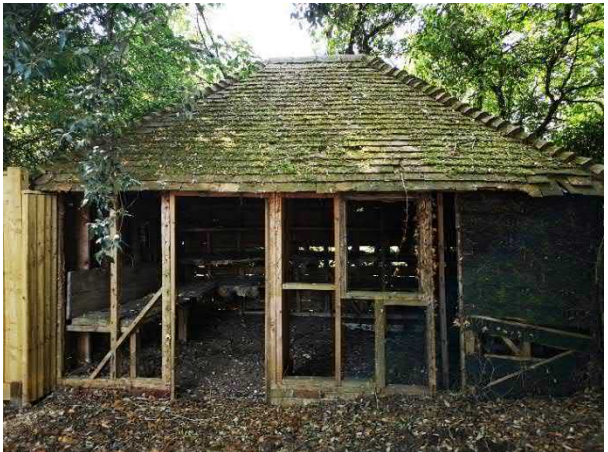
27	10320 – timber shed

southern elevation at the time of the survey		
27	10320 - Timber shed	<ul style="list-style-type: none"> External PRA 	SU 96979 06853	Timber framed out-building with clay roof tiles and single skin timber clad walls. The building was in a poor state of repair and was missing the northern elevation wall.	No features suitable for roosting bats observed	Negligible
28	10320 - Stable block	<ul style="list-style-type: none"> External PRA 	SU 96975 06888	Timber stable block with bitumen felt covered roof. Appears highly disturbed inside as used as a workshop with internal lighting	No features suitable for roosting bats observed	Negligible
29	10320 – Stable block	<ul style="list-style-type: none"> External PRA 	SU 96930 06864	Open-fronted timber stable block used for storage. No windows or doors and large hole in roof allowing significant light ingress and limited temperature regulation.	No features suitable for roosting bats observed	Negligible

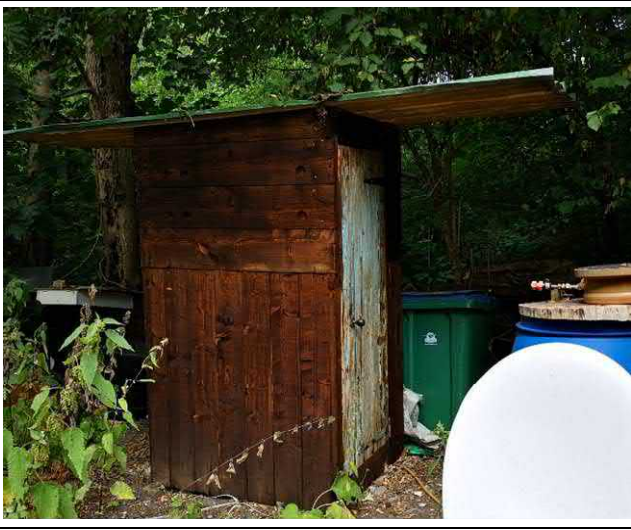
49	12735 – timber framed structure

49	12735 - Timber framed structure	<ul style="list-style-type: none"> External PRA 	SU 97549 06818	A timber framed and clad construction, dimensions approx.	No features suitable for roosting bats observed	Negligible

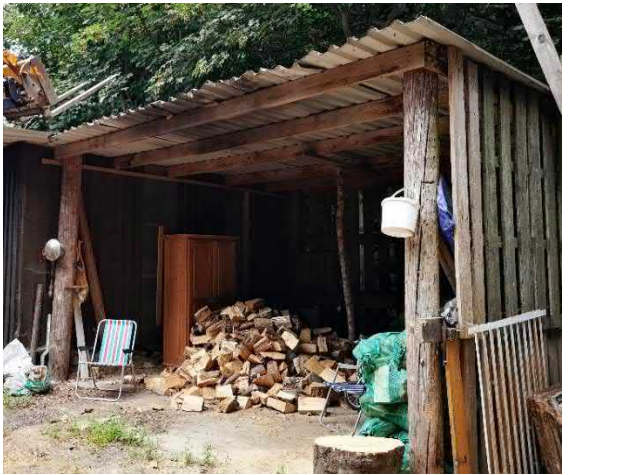
50	12735– timber framed structure

1x1m covered with a corrugated metal roof		
50	12735 - Timber framed structure	<ul style="list-style-type: none"> External PRA 	SU 97549 06818	Timber framed and clad wood store shed with a flat corrugated metal roof and open elevations to the south with large gaps along the north and east elevations.	No features suitable for roosting bats observed	Negligible
51	12735 - Timber framed structure	<ul style="list-style-type: none"> External PRA 	SU 97549 06818	Timber-framed and clad storage unit with sections of corrugated Perspex on the eastern elevation and is clad with a corrugated metal flat roof.	No features suitable for roosting bats observed	Negligible
52	12735 - Metal container	<ul style="list-style-type: none"> External PRA 	SU 97549 06818	Metal shipping container with no obvious features	No features suitable for roosting bats observed	Negligible
53	12735 - Metal container	<ul style="list-style-type: none"> External PRA 	SU 97548 06808	Metal trailer/ storage unit with wire mesh along the lower half of the western elevation. Gaps present above the door on the western elevation, multiple holes throughout.	No features suitable for roosting bats observed	Negligible

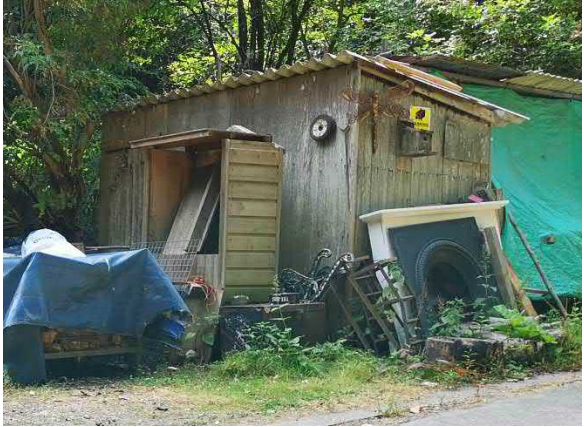
58	12735 – timber framed structure

58	12735 - Timber framed structure	<ul style="list-style-type: none"> External PRA 	SU 97520 06820	Timber-framed shed, corrugated asbestos roof, plywood and timber	No features suitable for roosting bats observed	Negligible

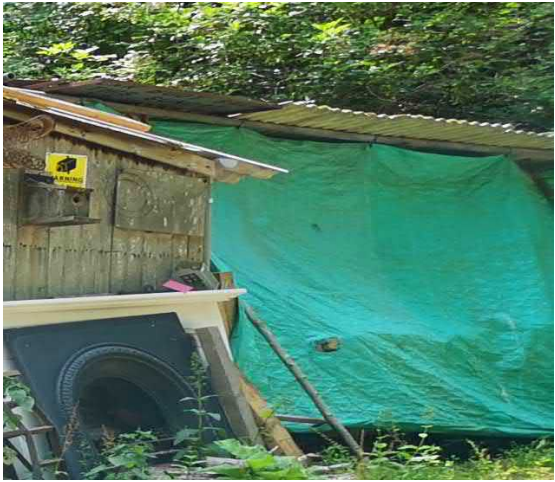
59	12735 – timber framed structure

skin, gaps along top of wall into inside		
59	12735 - Timber framed structure	<ul style="list-style-type: none"> External PRA 	SU 97520 06820	Timber-framed corrugated metal clad (north) and timber/boarding (south east and west elevations) storage building. Large hole on northern elevation.	No features suitable for roosting bats observed	Negligible
60	12735 - Timber framed structure	<ul style="list-style-type: none"> External PRA 	SU 97559 06760	Timber framed pre-fabricated building. Derelict. Timber weatherboarding with bitumen roof lining underneath timber weatherboarding. Open to the elements along the entire western elevation. Corrugated asbestos roof. Open and damaged windows on west, east and south elevations. Large gaps to internal space between roof and top of walls. Opening at top of doorway into structure as well as gaps under the eaves of the asbestos roof giving access to the interior	No features suitable for roosting bats observed	Negligible

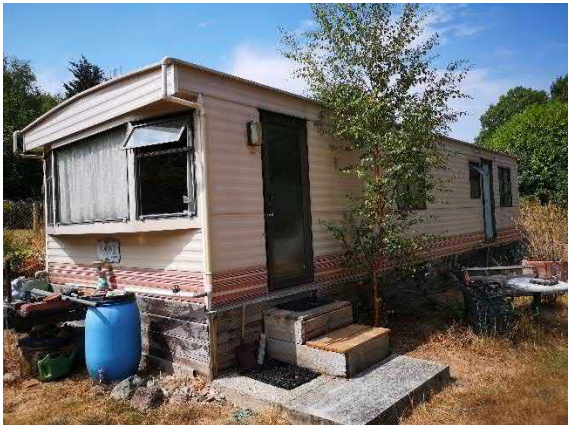
61	12735 – static caravan

space along the eastern elevation. Building sitting on concrete stilts. Wooden fascia on north and south elevations.		
61	12735 - Static caravan	<ul style="list-style-type: none"> External PRA 	SU 97565 06717	Corrugated metal framed and clad static caravan. Timber boarding along ground where caravan is lifted on stilts.	No features suitable for roosting bats observed	Negligible
62	12735 - Timber shed	<ul style="list-style-type: none"> External PRA 	SU 97618 06685	timber-framed and clad potting shed approximately 2.5x1.5m with a sloped bitumen felt lined roof. Gaps and open window present on the western elevation. Ivy covering and some warping of timber cladding.	No features suitable for roosting bats observed	Negligible
63	12735 - Timber shed	<ul style="list-style-type: none"> External PRA One emergence and one re-entry survey 	SU 97627 06658	Timber framed single storey building clad with timber weatherboarding. Timber soffit box around roof. Bitumen roofing felt with corrugated metal sheeting	Gaps between corrugated sheeting and bitumen. Gap between 'little woods nursery' sign and timber boarding on south-western elevation	Low – Confirmed roost

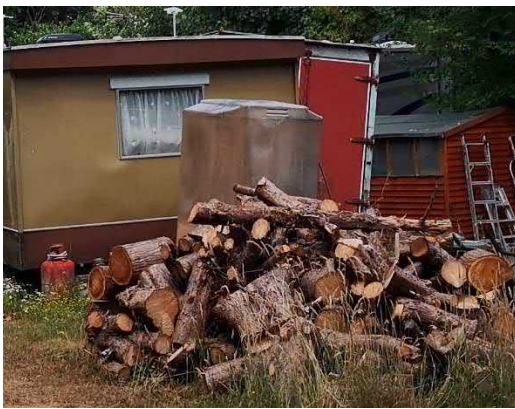
67	12735 – metal container

67	12735 - Metal container	<ul style="list-style-type: none"> External PRA 	SU 97644 06624	Large live-in horse trailer with no visible crevices.	No features suitable for roosting bats observed	Negligible
68	12735 - Metal container	<ul style="list-style-type: none"> External PRA 	SU 97644 06624	Large live-in horse trailer with no visible crevices.	No features suitable for roosting bats observed	Negligible
69	12735 - Metal container	<ul style="list-style-type: none"> External PRA 	SU 97644 06624	Metal shipping container with flat roof and no visible crevices.	No features suitable for roosting bats observed	Negligible

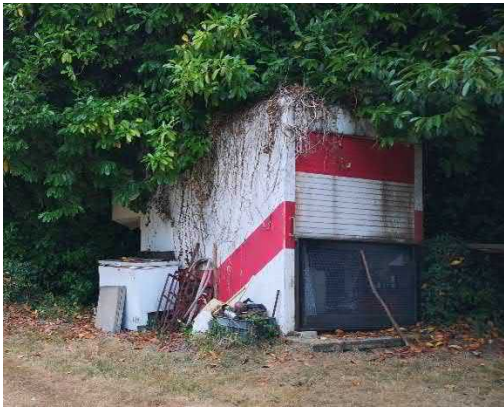
70	12735 – metal container

70	12735 - Metal container	<ul style="list-style-type: none"> External PRA 	SU 97644 06624	Metal shipping container with flat roof and no visible crevices.	No features suitable for roosting bats observed	Negligible
71	12955 - Dwelling house	<ul style="list-style-type: none"> External PRA Internal PRA 	TQ 02843 05649	<p>Brick semi-detached dwelling with pitched and gable end roof clad with clay tiles.</p> <p>Large roof void extends throughout whole roof space. Simple timber frame roof with purlins, rafters, and ridgeboard. Fully lined with bitumen felt. No light ingress; low temperature. Large, uncluttered void suitable for maternity roost. No discernible access points. No evidence of roosting bats observed.</p>	Few entry/ exit points observed. Hanging tiles at south and north elevations as first floor level.	Moderate
72	12955 - Timber-framed structure	<ul style="list-style-type: none"> External PRA 	TQ 02848 05660	Timber structure with some corrugated metal panelled walls and partially boarded windows. Flat, bitumen covered roof.	No features suitable for roosting bats observed	Negligible

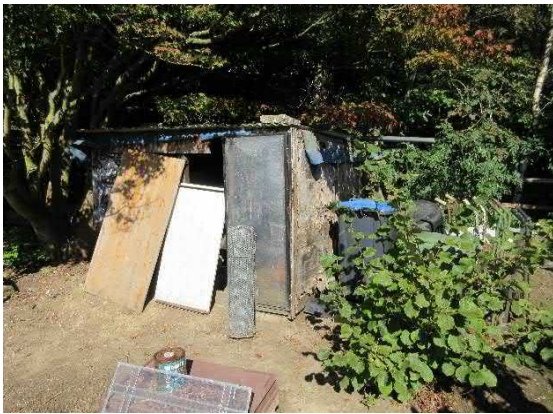
73	12955 – timber framed structure

73	12955 - Timber-framed structure	▪ External PRA	TQ 02857 05659	Metal and timber walled structure with flat, corrugated metal roof. Large gaps in walls.	No features suitable for roosting bats observed	Negligible
74	12955 - Timber-framed structure	▪ External PRA	TQ 02862 05657	Timber and corrugated metal walls with flat corrugated metal roof. Windows allowing light ingress	No features suitable for roosting bats observed	Negligible
75	12955 - Timber-framed structure	▪ External PRA	TQ 02863 05647	Timber framed structure with corrugated metal pitched roof. No visible crevices.	No features suitable for roosting bats observed	Negligible
76	12955 - Garage	▪ External PRA	TQ 02855 05638	Concrete block construction, pitched and gable roof clad with bitumen felt. Intact and modern.	No features suitable for roosting bats observed	Negligible
77	10280 – type unconfirmed	▪ External PRA	SU 97016 06743	Not surveyed – no access permission	Not surveyed – no access permission	Unknown
